Technical Inspection Report
Bureau of Ordnance Group

6
OPERATION CROSSROADS.

TESTS 'A' AND 'B'.
VOLUME IV.
PART X. PHOTOGRAPHIC
APPENDIX [U].

GUNS AND MOUNTS PHOTOGRAPHIC INDEX

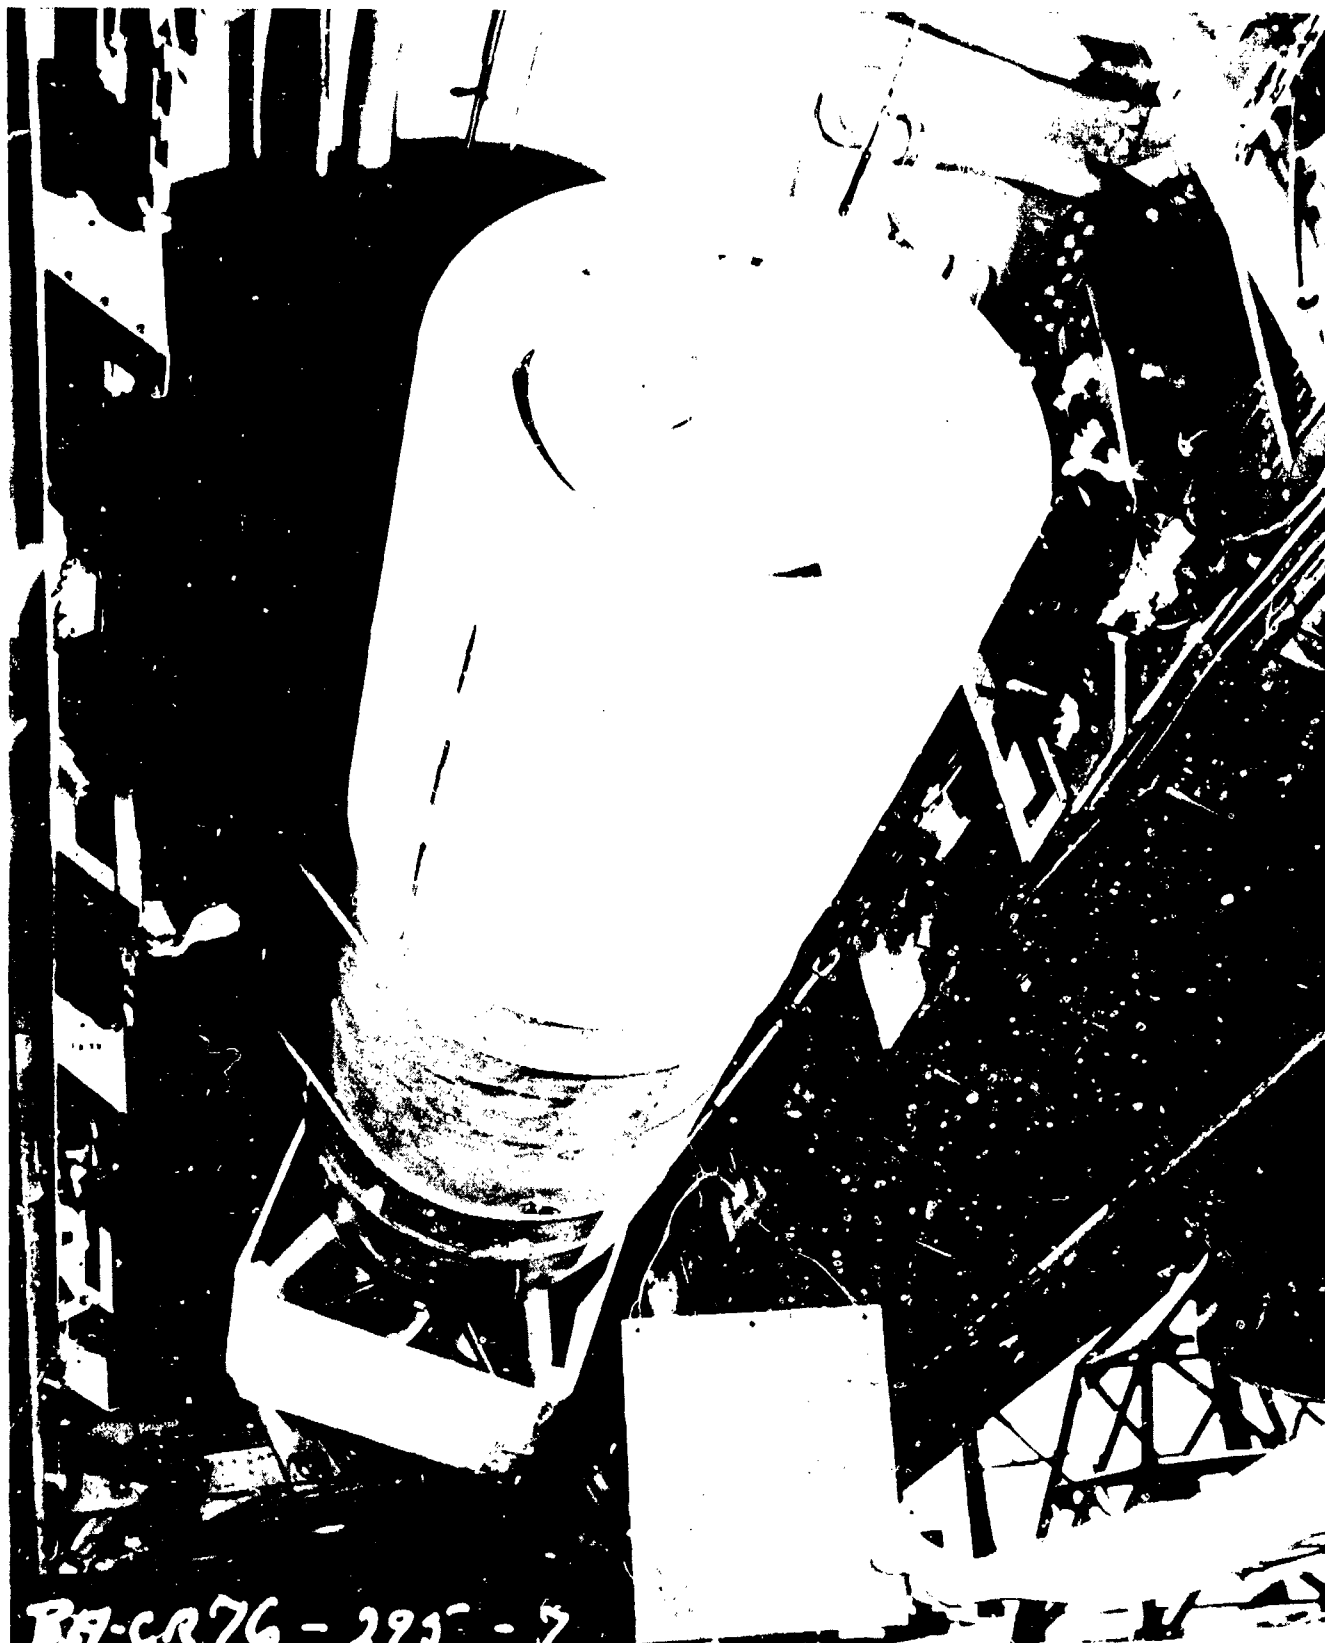
U.S.S. INDEPENDENCE (CVL-22) - Before Able Mine, Mk. 24 loaded in TBM on flight deck.
Photo. No. BA-CR-76-295-7.

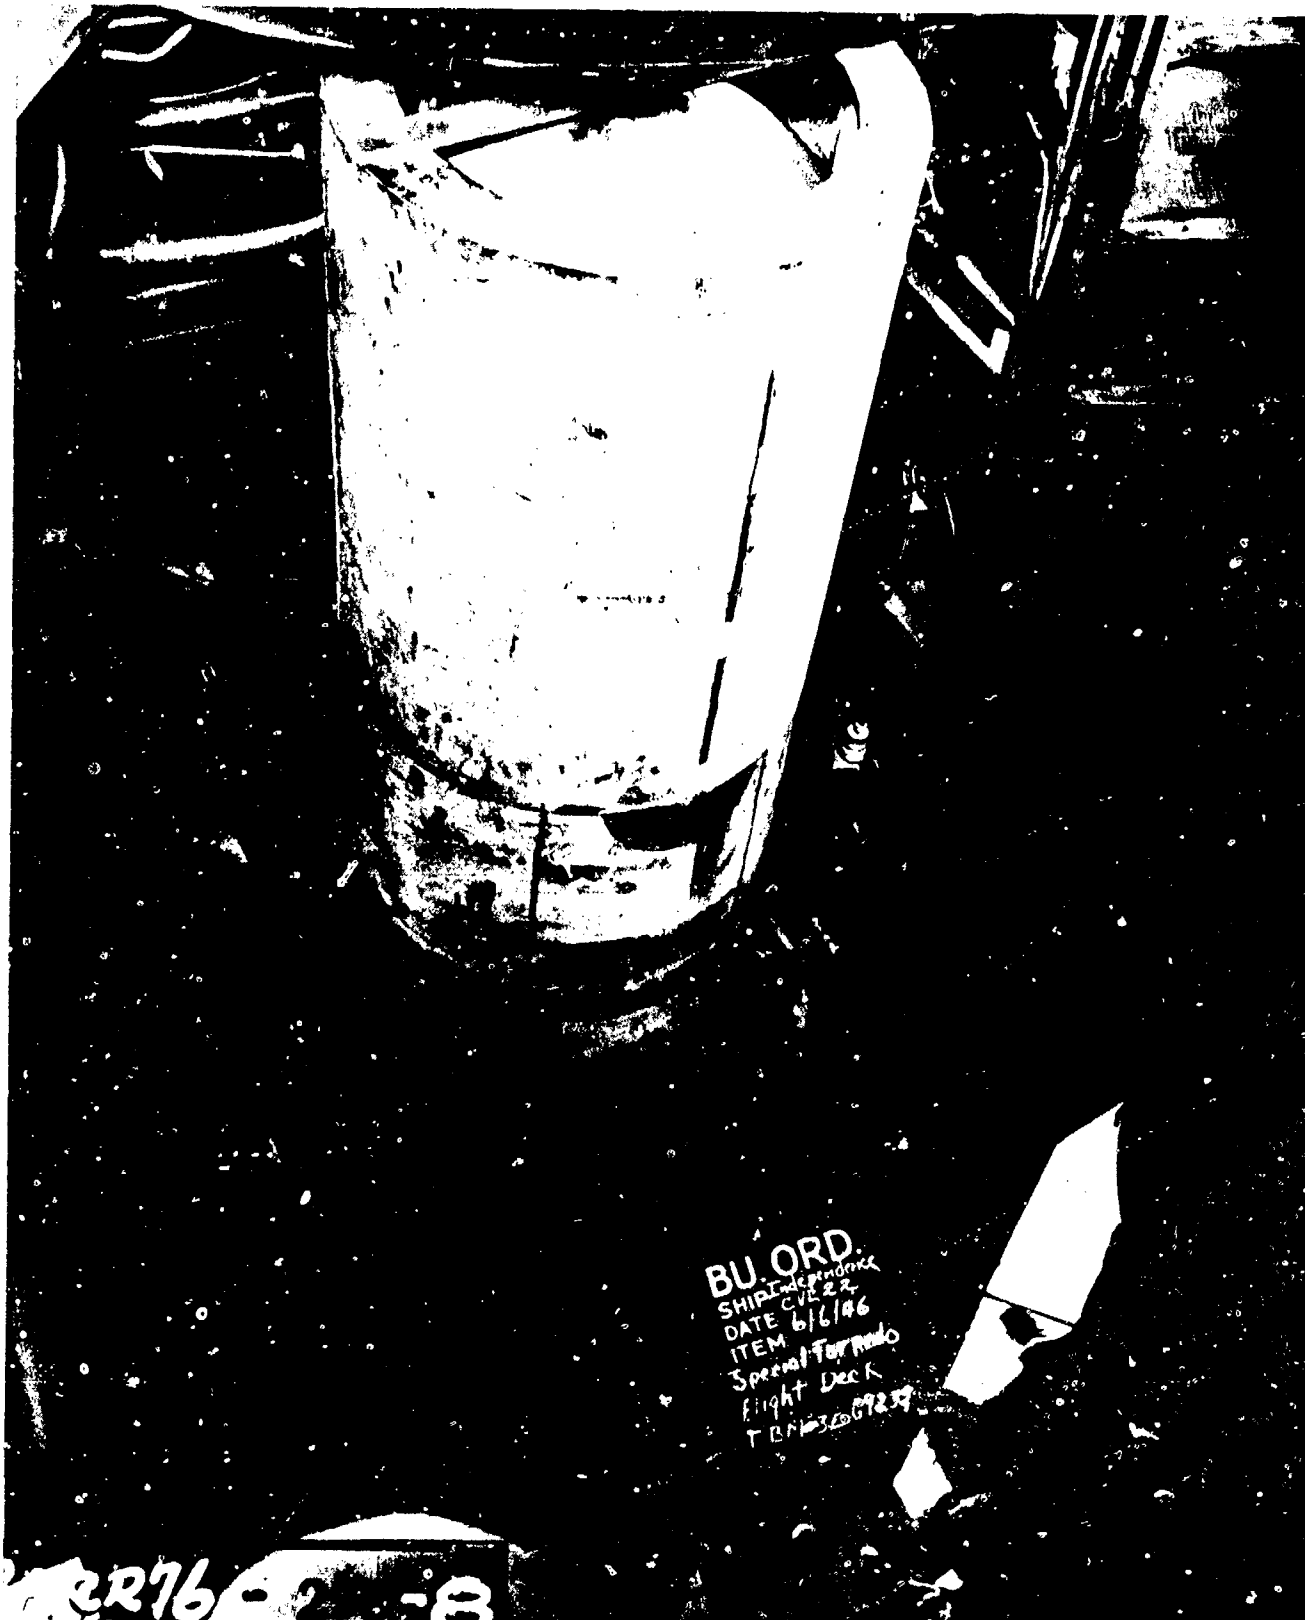
U.S.S. INDEPENDENCE (CVL-22) - Before Able
Aircraft Torpedo loaded in plane on flight
deck.
Photo. No. NA-CR-76-295-8.

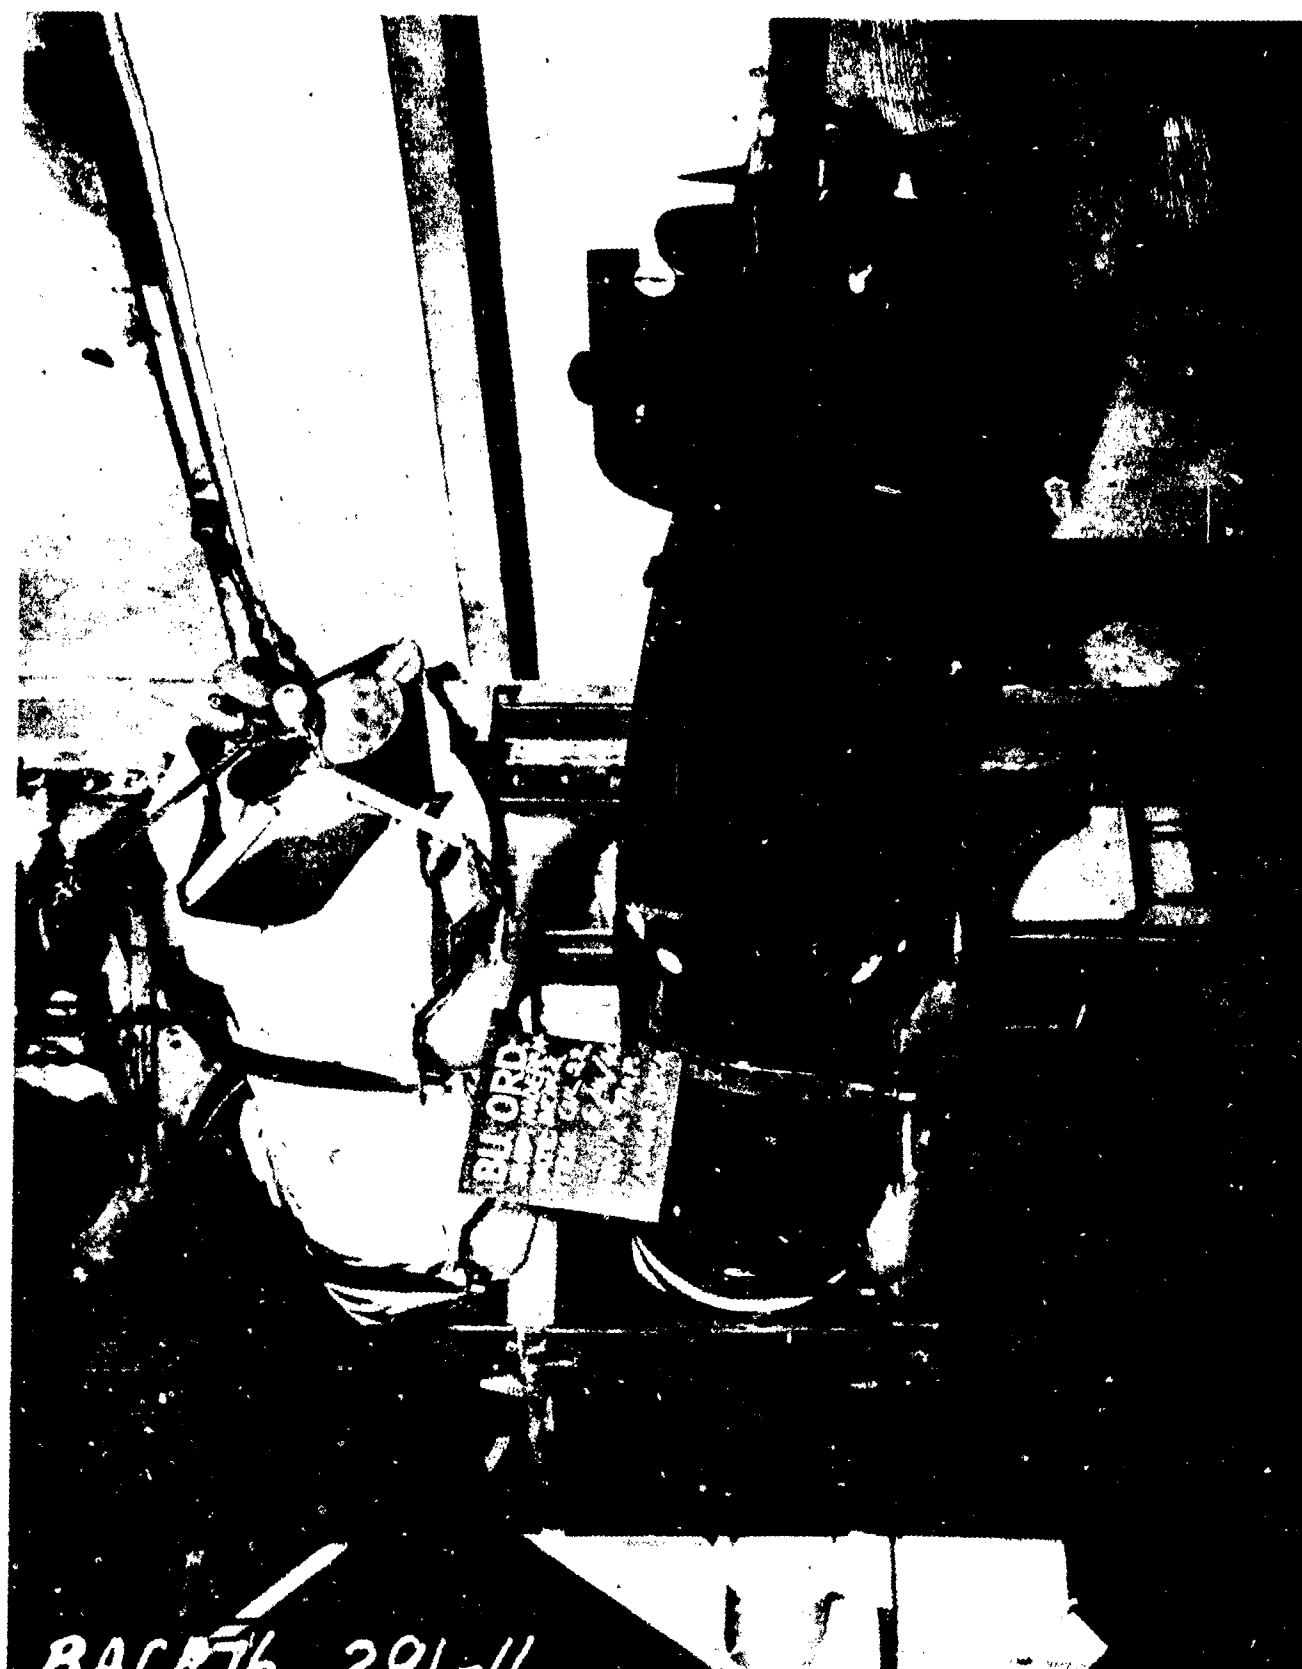
U.S.S. INDEPENDENCE (CVL-22) - Before Able
Showing Aircraft Torpedo and Mine, Mk. 24
in ready stowage on hanger deck.
Photo. No. BA-CR-76-291-11.

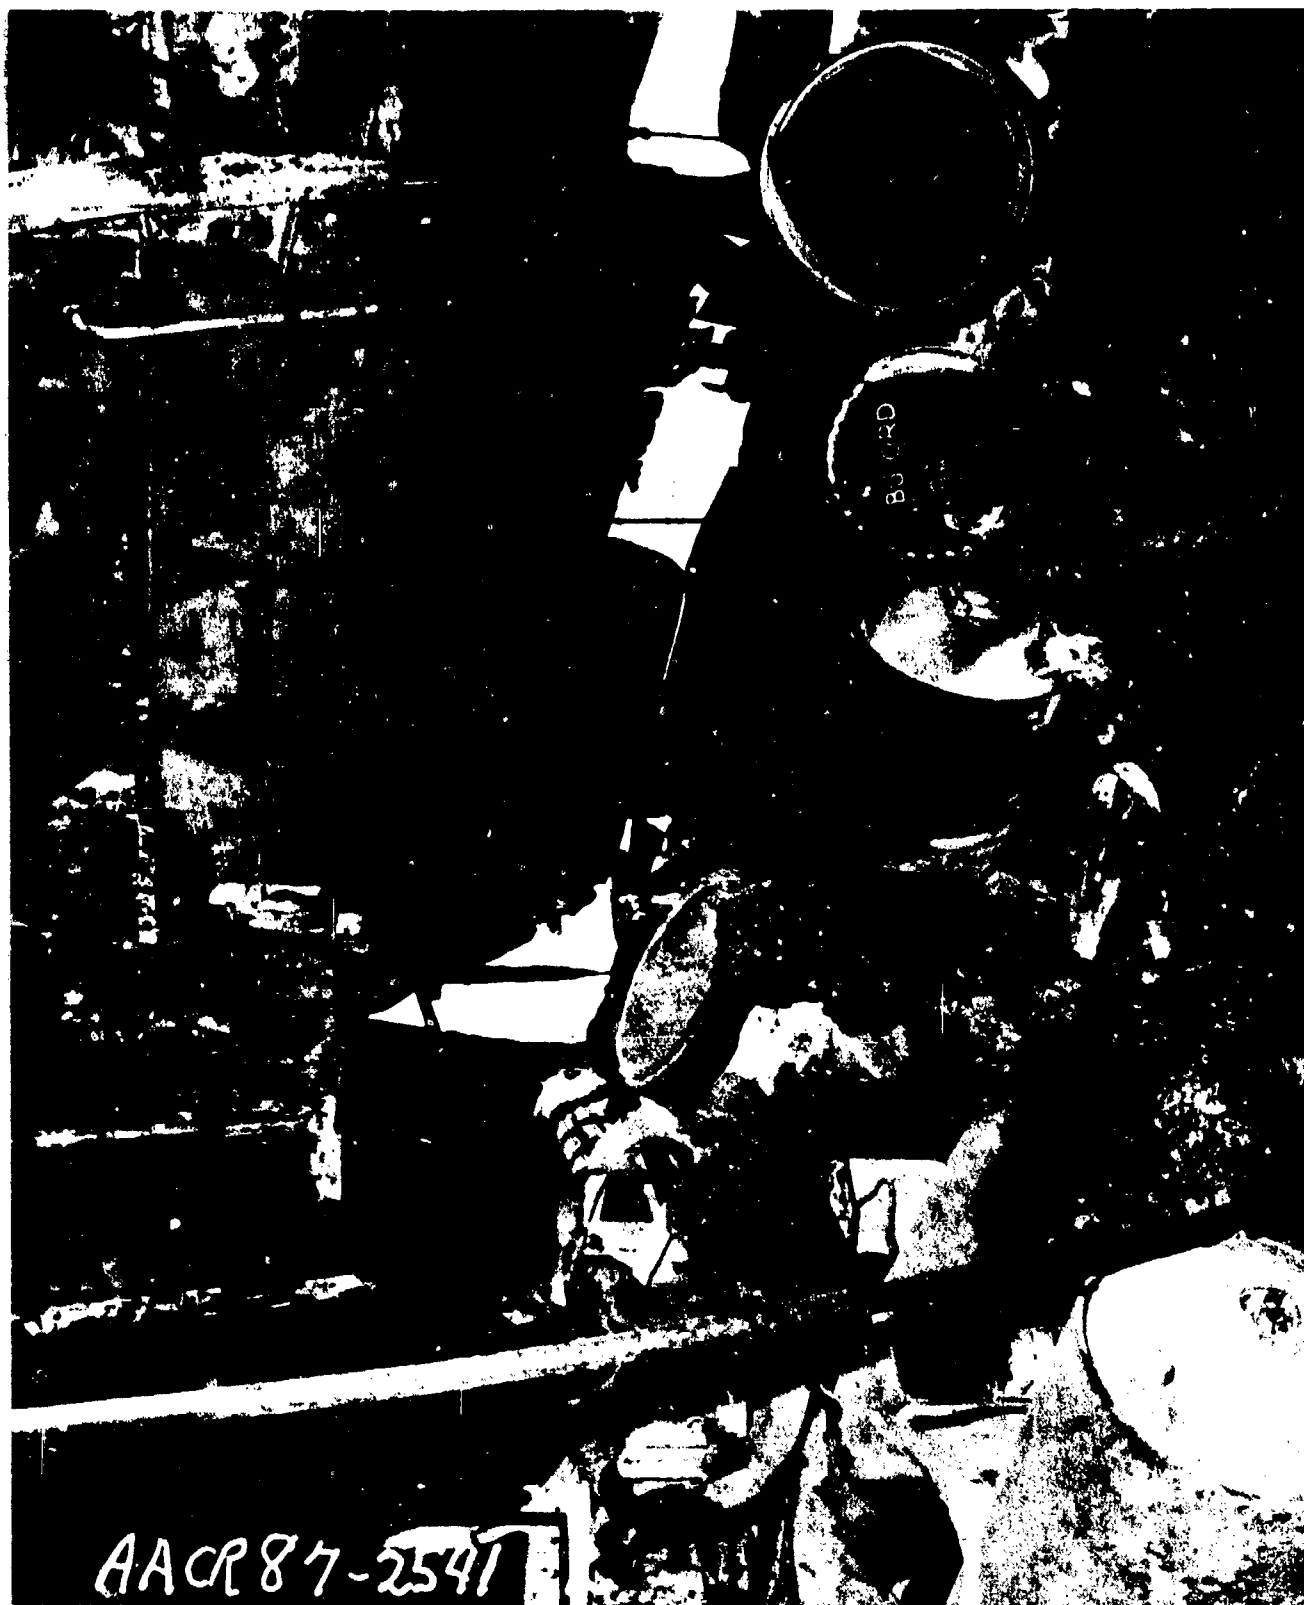
U.S.S. INDEPENDENCE (CVL-22) - After Able
Damage to torpedo stowage compartment C-101B.
Note some of the airflasks are in tact.
Photo. No. AA-CR-87-2541-2.

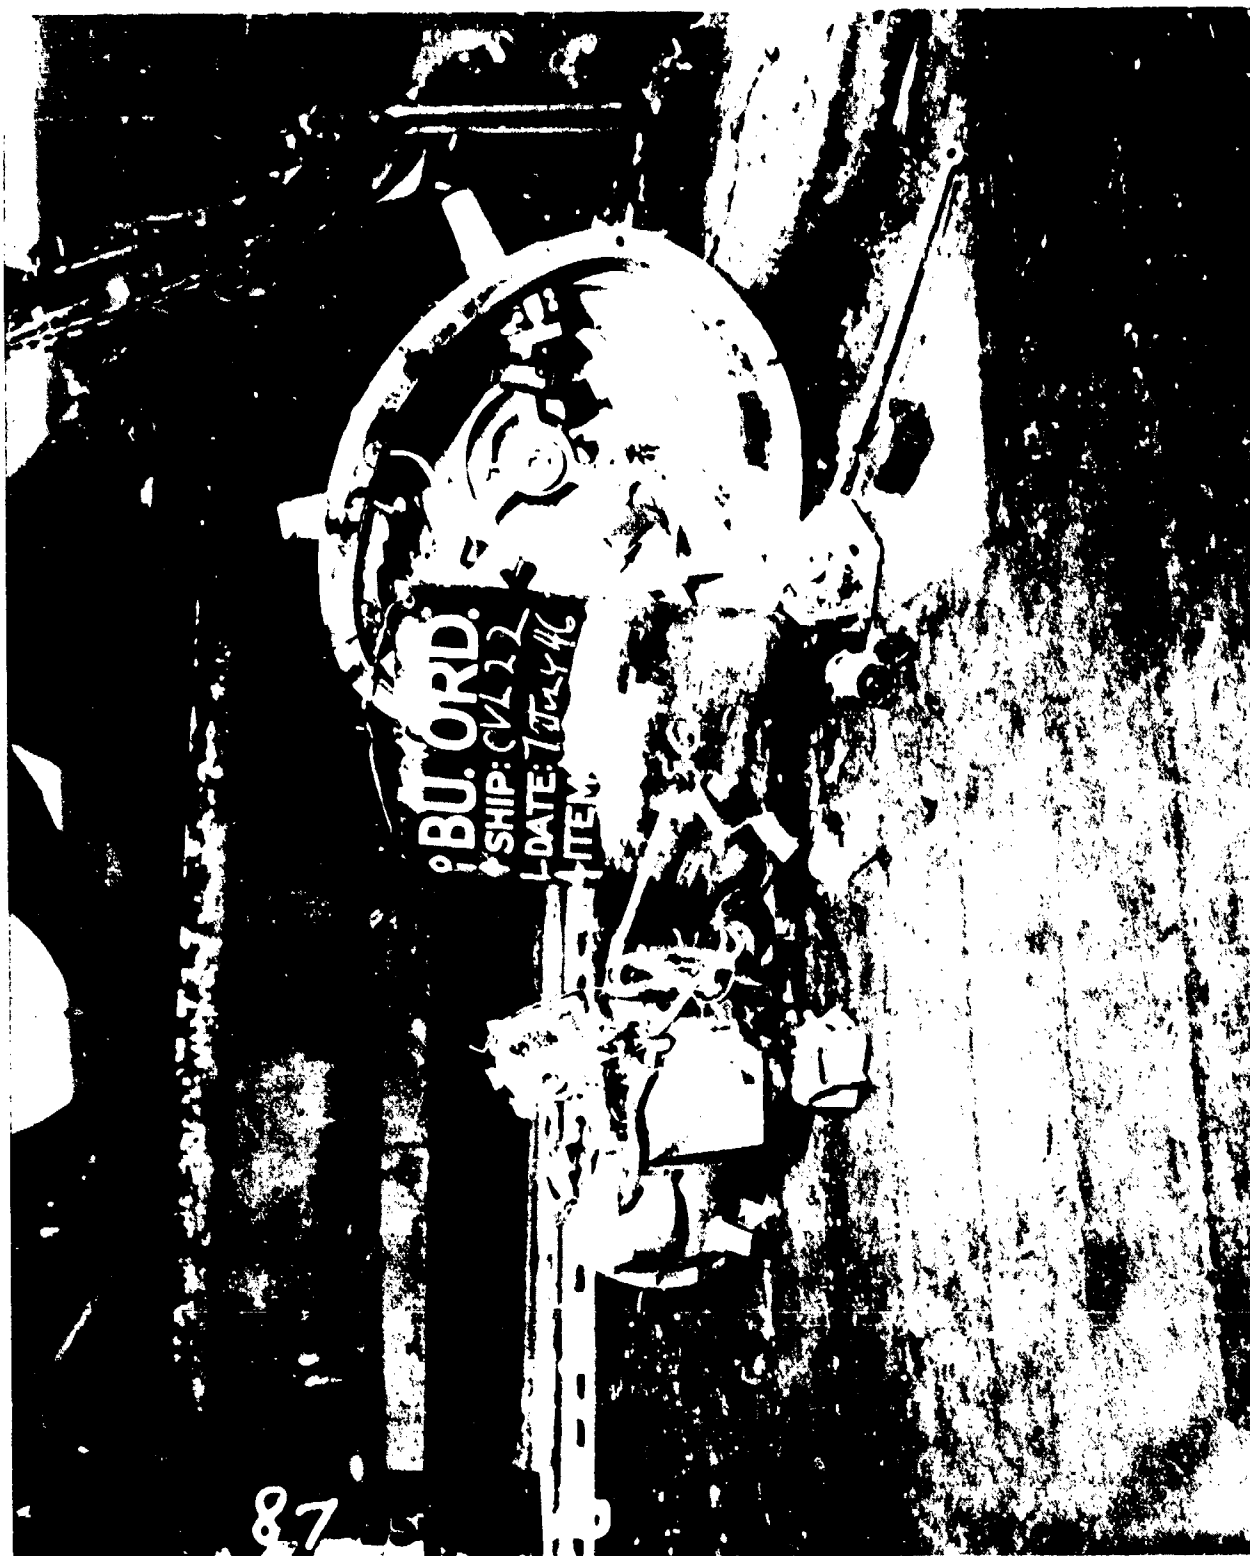
U.S. INFANTRY (CVL-22) - After Able
 Distorted Tail Section of Mine, Mk. 14 that
 originally was in plane on flight deck. Plane
 warped and cylinder were blown overboard by
 blast.
 Photo. No. AA-GR-87-2541-10.

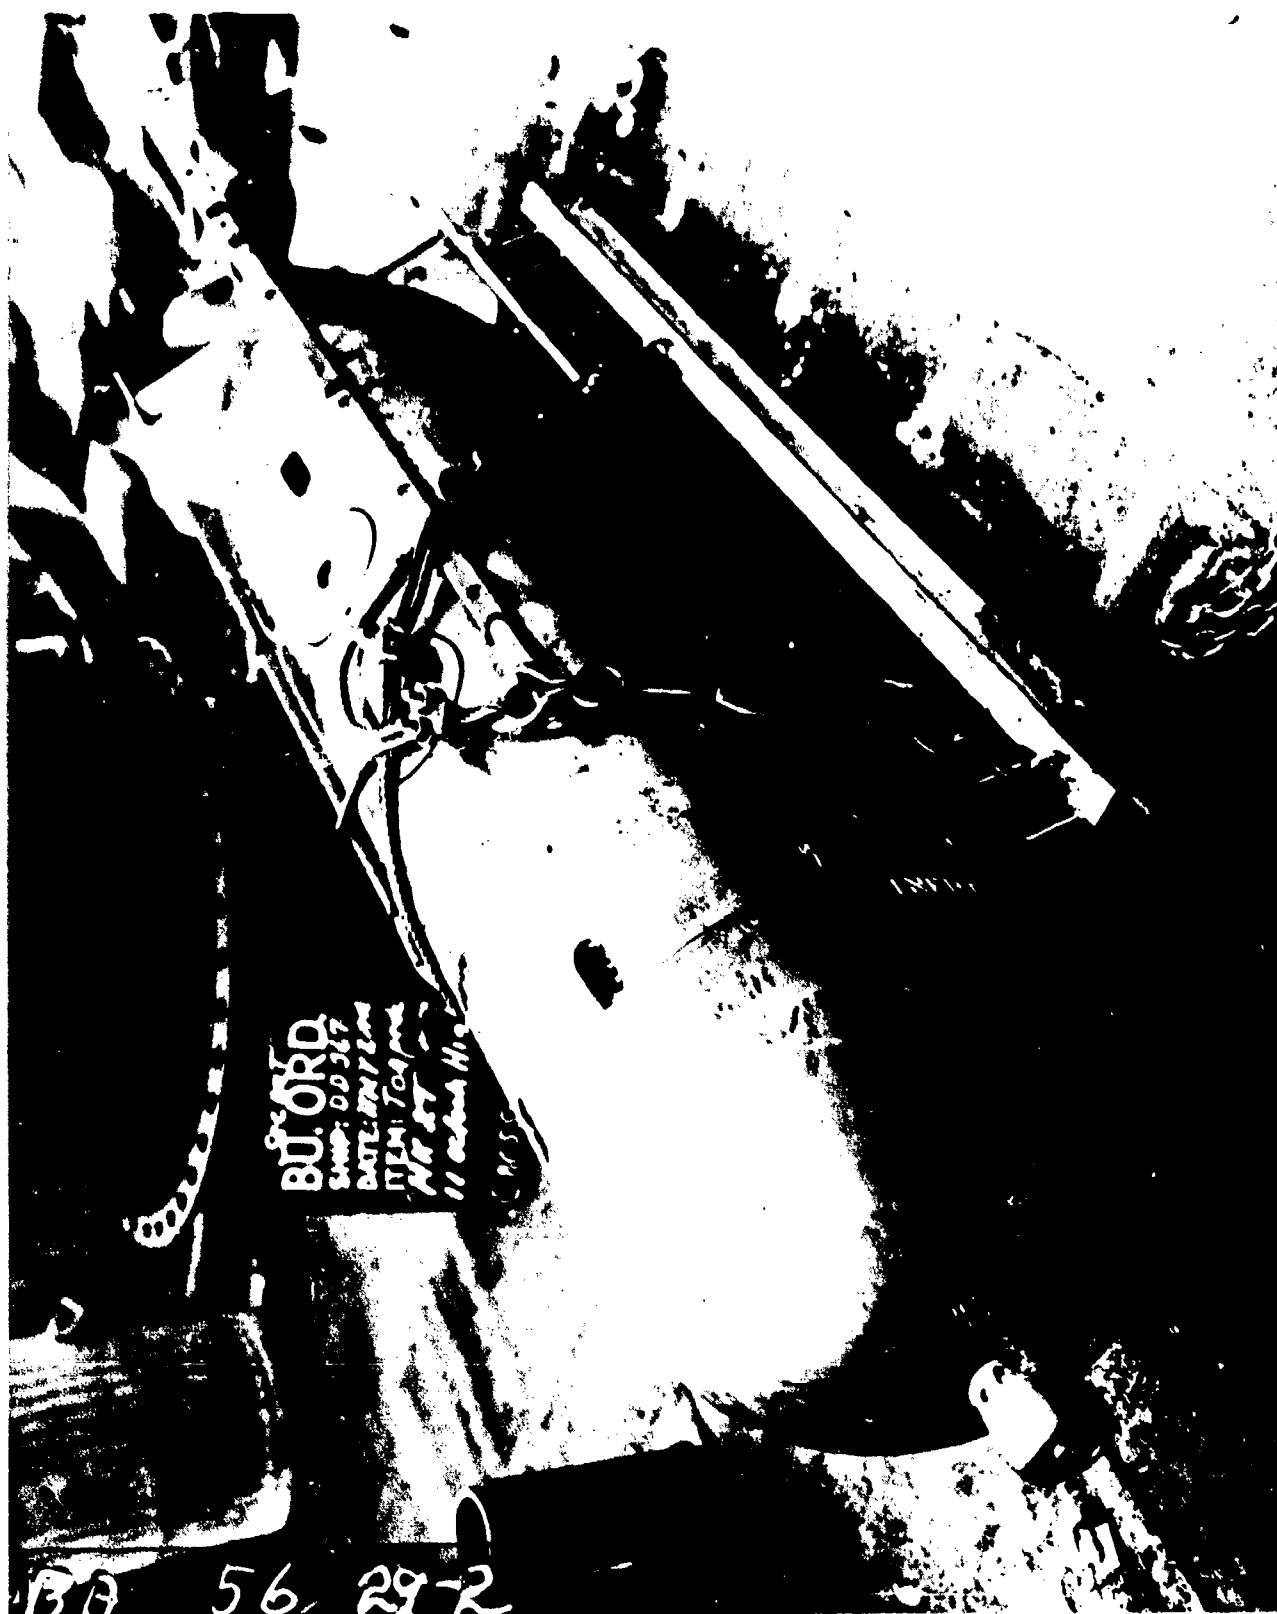
U.S.S. LAMSON (DD-367) - Before Able
 Showing typical placement of special
 weapon on fantail of destroyers.
 Photo. No. EA-CR-56-29-2.

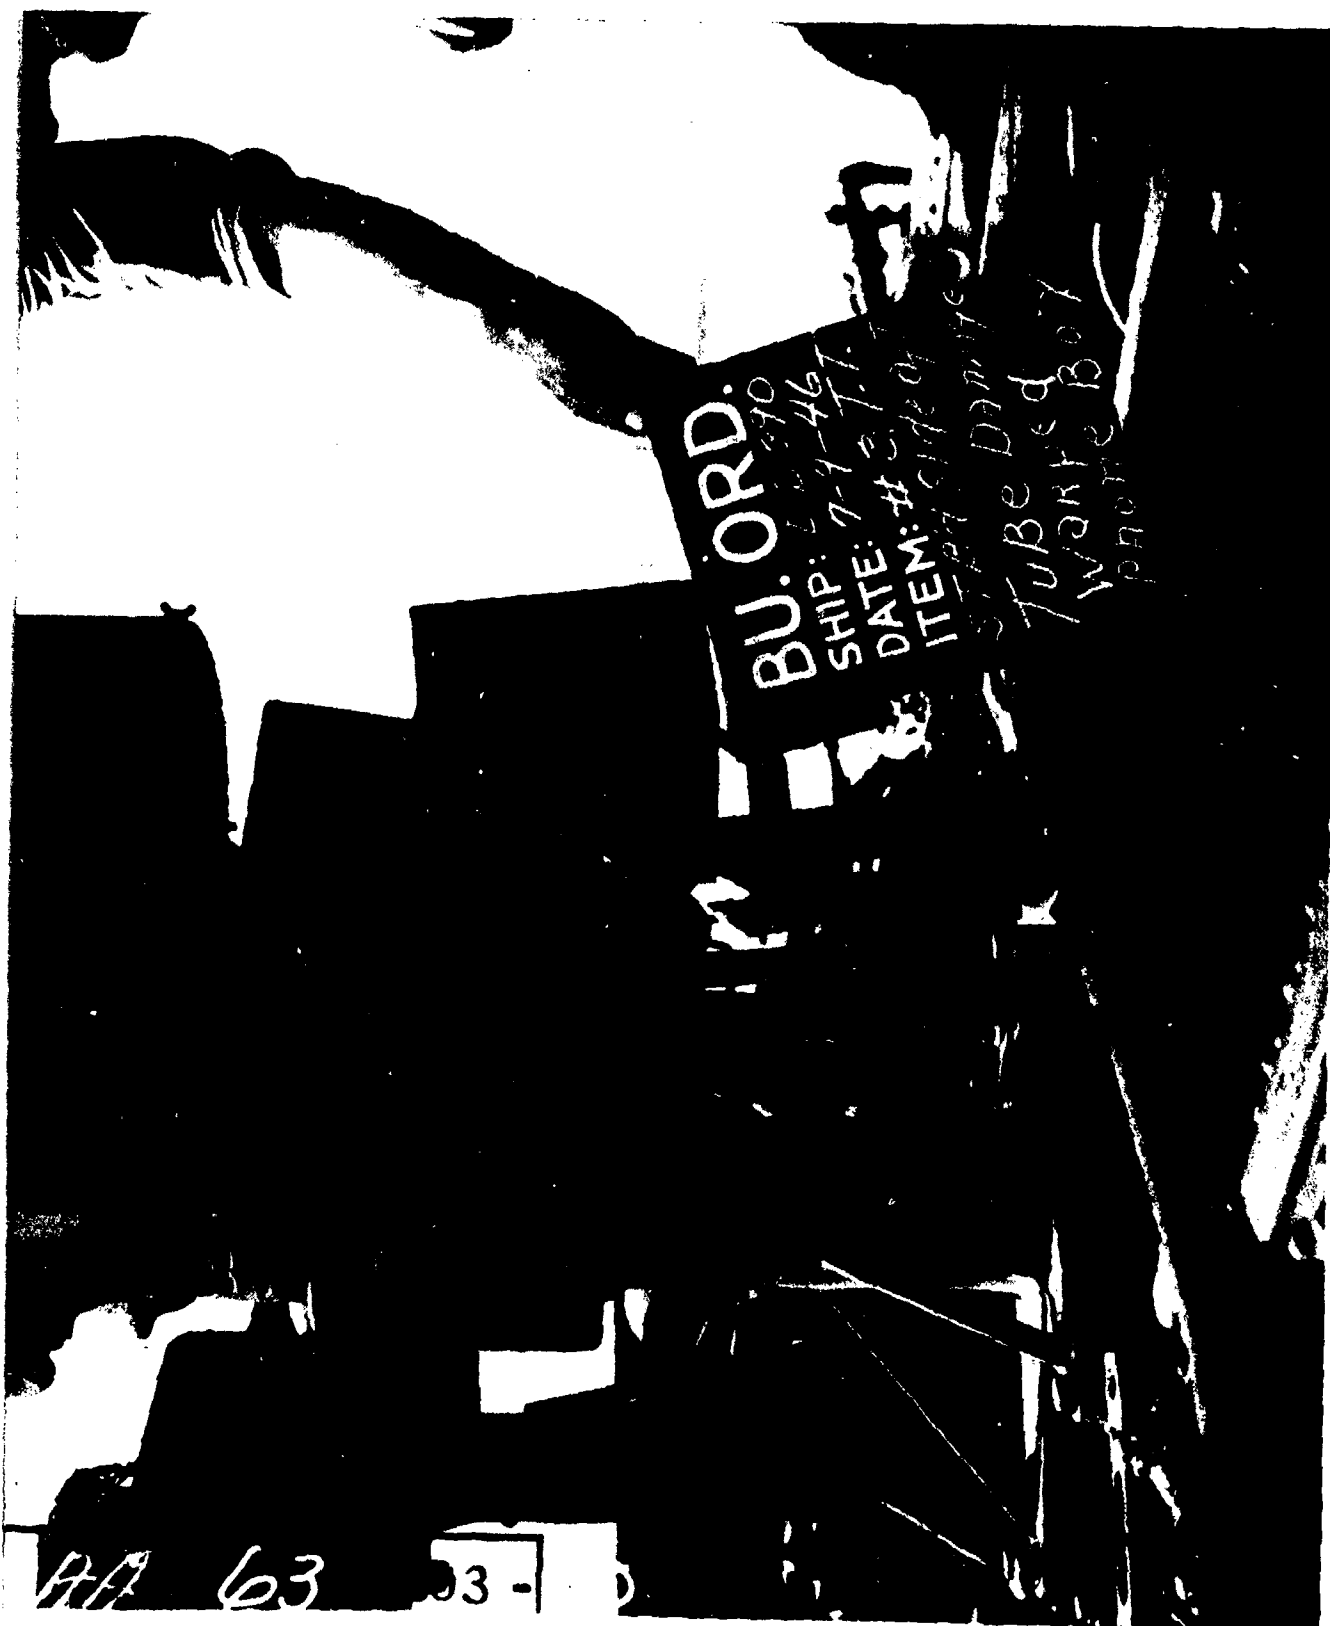
U.S.S. RALPH TALBOT (DD-390) - After Able
Torpedo Tube Aft Starboard Side, showing
damaged phone box.
Photo. No. AA-CR-63-1703-10.

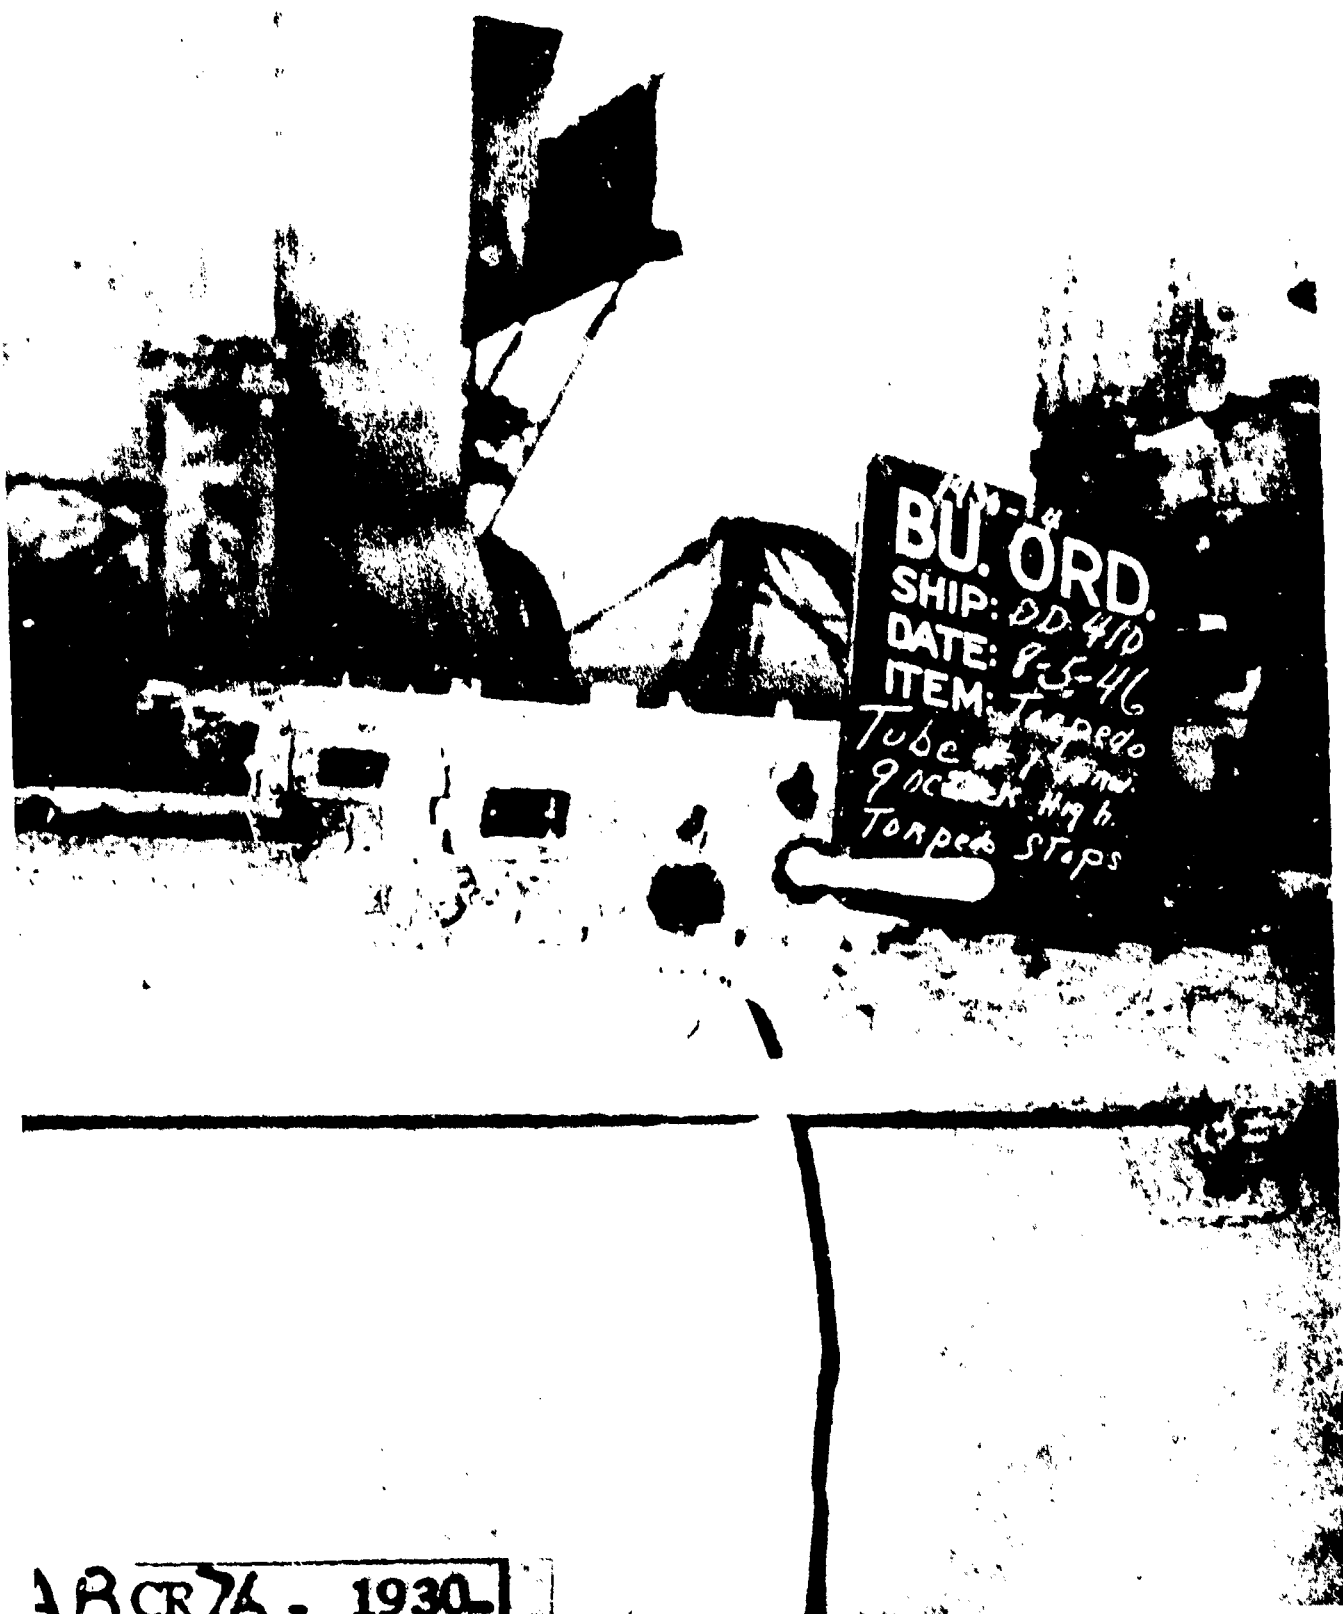
ABCR 76 - 1930

U.S.S. HUGHES (DD-410) - After Baker
 Showing torpedo stop tension links carried away.
 Photo. No. AB-OR-76-1930-5.
